**MIANUS RESERVOIR DAM
CT 00050**

**PHASE I INSPECTION REPORT
NATIONAL DAM INSPECTION PROGRAM**

DEPARTMENT OF THE ARMY
NEW ENGLAND DIVISION, CORPS OF ENGINEERS
WALTHAM, MASS. 02154

SEPTEMBER 1978

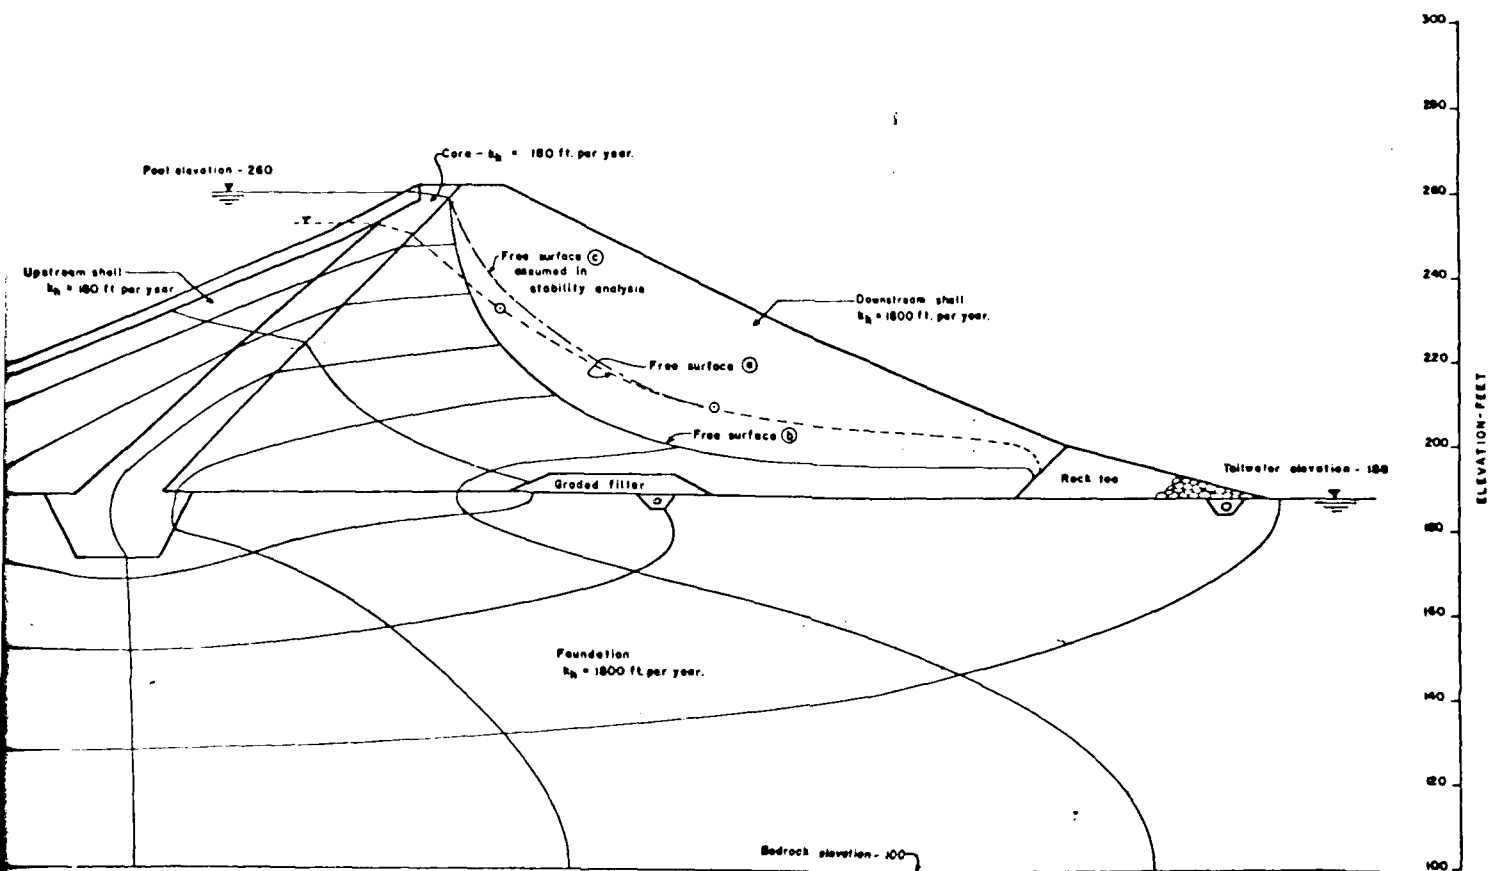
FLOW NET AT CROSS SECTION 5+0

The flow net for a section of the dam at Station 5+0 is shown in Figure 1. In sketching the net, it was assumed, based on field control reports, that the upstream shell and core were of the same permeability and that it was one-tenth that of the downstream shell. For the purpose of drawing the flow net the downstream shell and foundation were assumed to have equal permeabilities and the stratification ratio in all parts of the dam was assumed to be 9. Since the upstream portion of the embankment is relatively impermeable when compared with the foundation, seepage loss estimates may be made by considering the effects of the foundation and embankment individually without substantial error. This was done in all of the following analyses.

Calculations based upon the values of permeability assumed above, the flow net in Figure 1 and a pool elevation of 253, with proper allowance for the location of the measuring weir, result in an estimated seepage loss of 275,000 gallons per day. From curve (a) in Figure 3 at a pool elevation of 253, a reasonable estimate for measured seepage loss is 570,000 gallons per day. Permeability variations from field or laboratory test results by factors of 10 or even greater in deposits, such as those considered herein, are common. We therefore feel that the agreement between the estimated and the measured losses is entirely reasonable. The quantity of flow in itself does not affect stability and need only be considered from the standpoint of function for which the dam was constructed. The various factors that do affect stability are discussed in Part III.

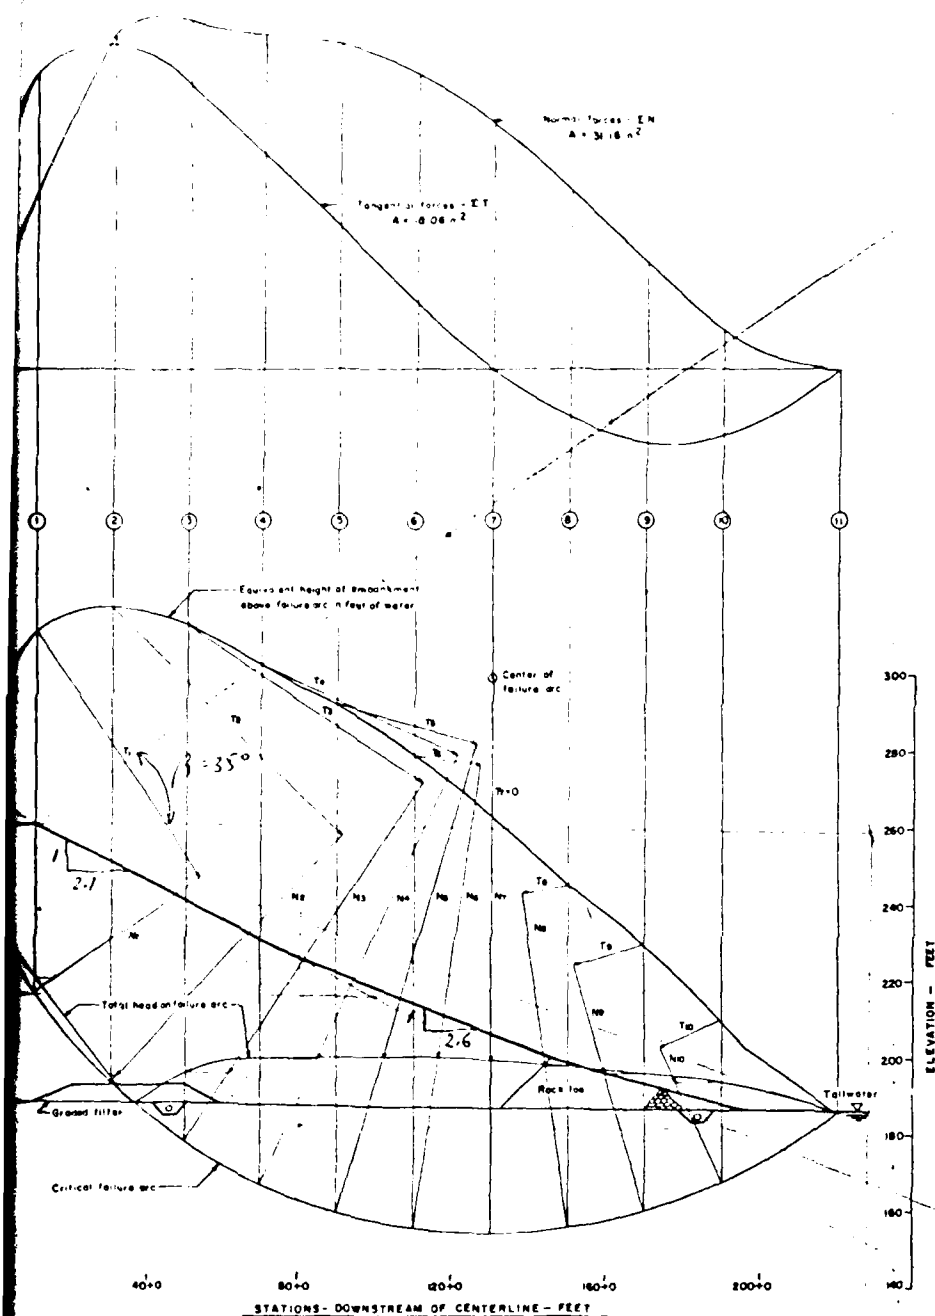
FIGURE 2

a. Friction Angle: As shown in the graph contained in Figure 2 increasing the friction angle markedly increases the factor of safety. The normal range of friction angles for soils of the type in the downstream portion of the embankment and the foundation is between 33 and 45 degrees, with the higher values being more prevalent.

cohesion. This relation is also evident from the graph in Figure 2. The rate of change of the factor of safety with the value of cohesion is greater for trial circles entirely in the embankment portion of the dam. This is true since a greater proportion of the total force resisting failure is in the cohesive strength for those circles. The foundation soils probably have low cohesion while the downstream materials would have only slight cohesion.

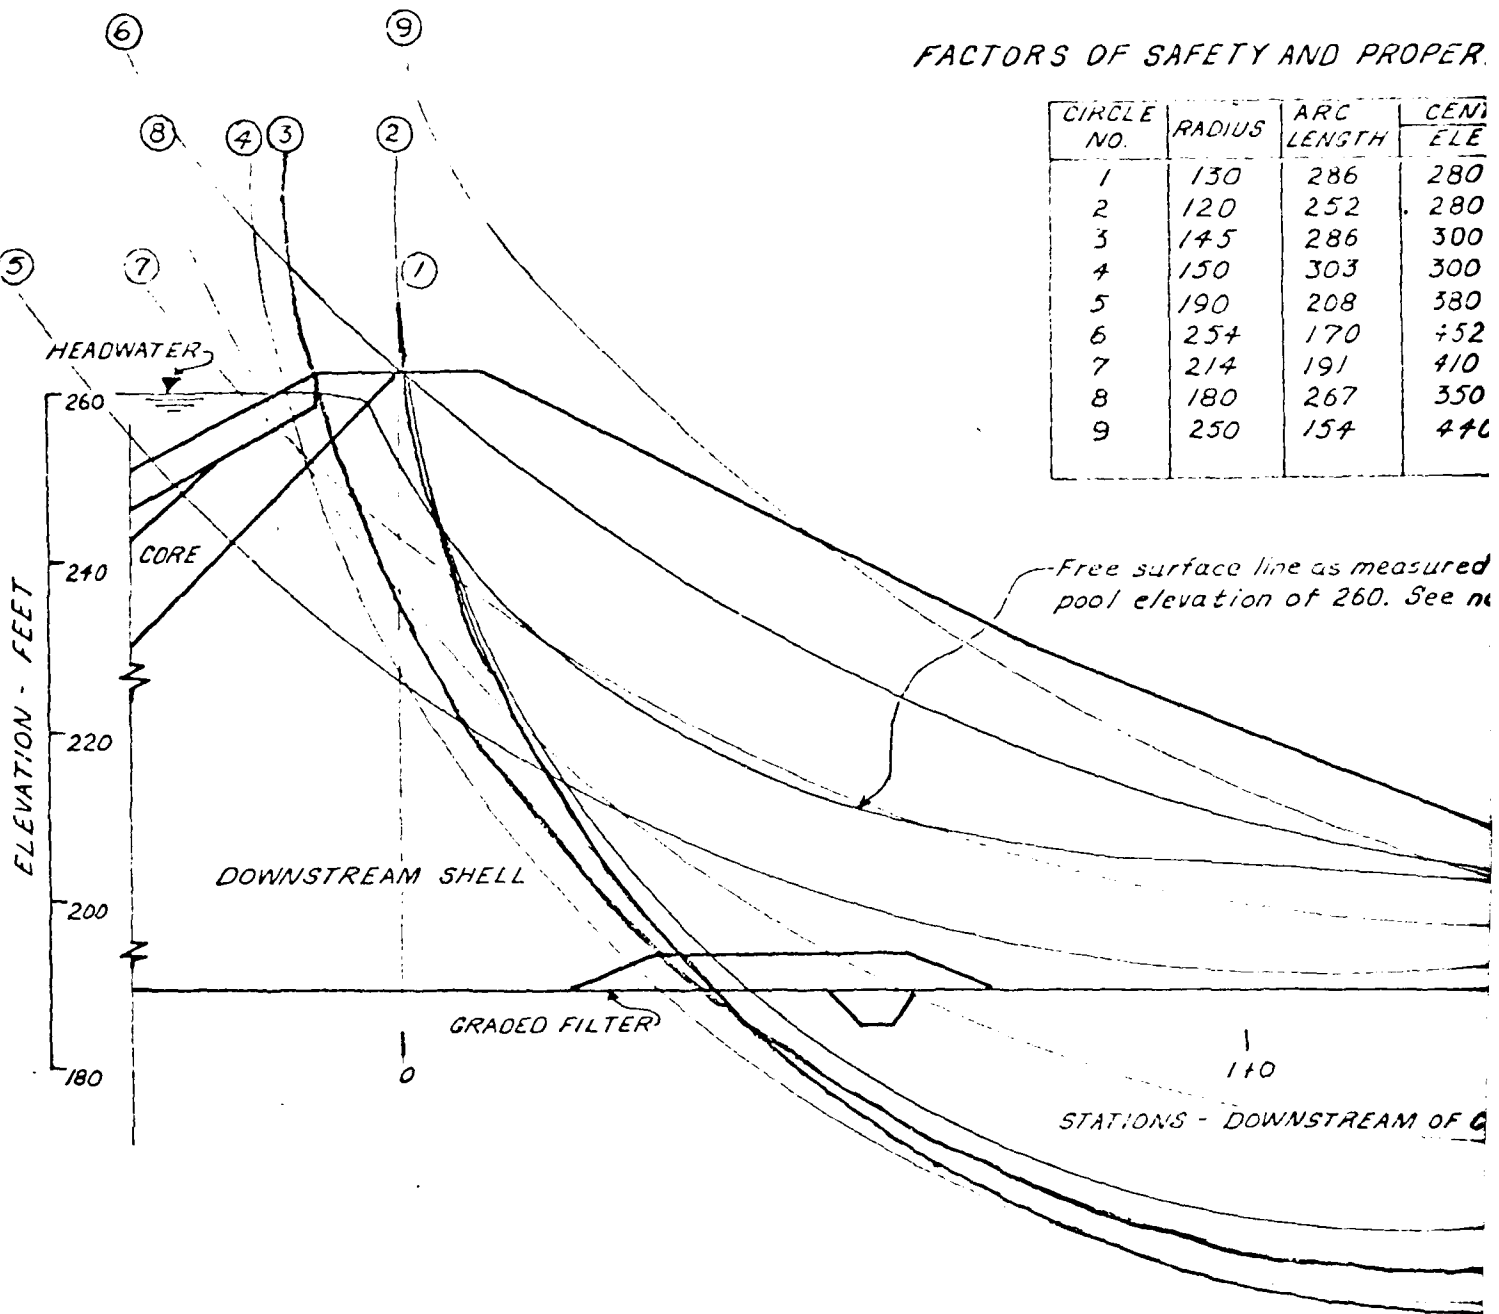
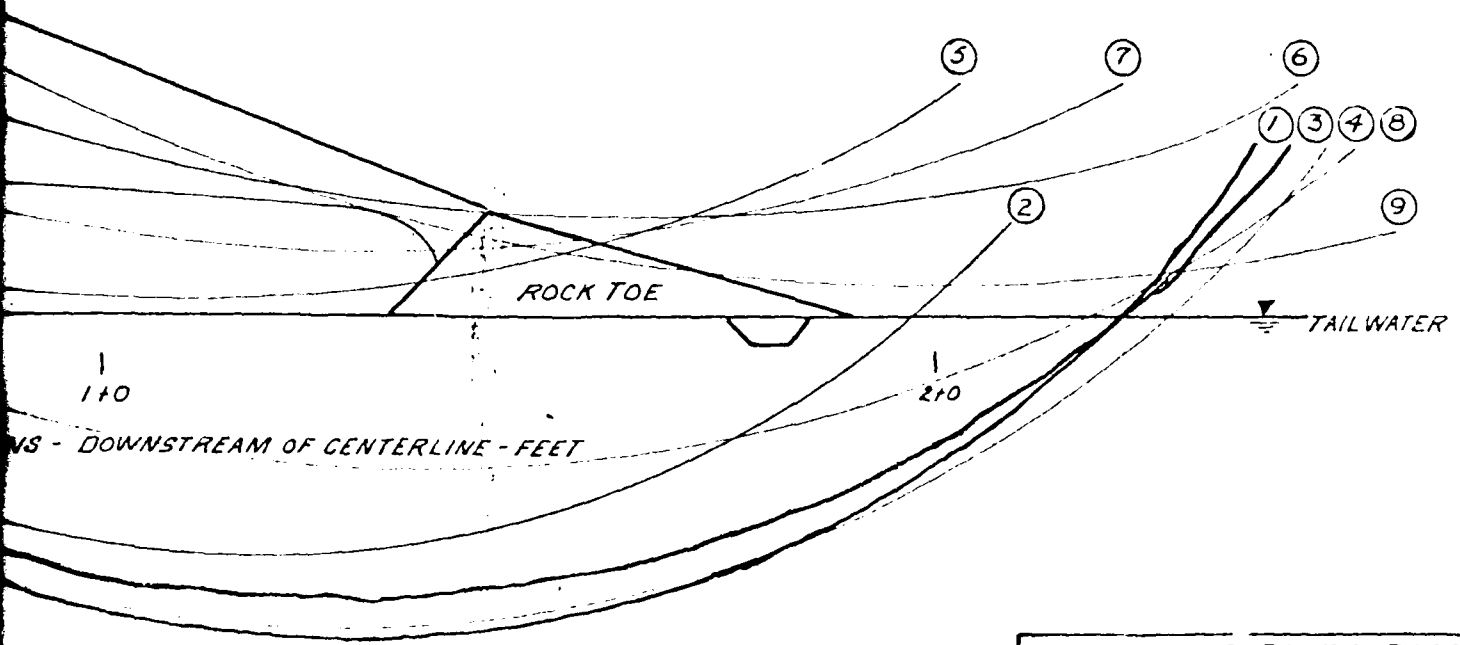
FIGURE 6

Stability analyses using the method shown in Figure 2 on the trial circles shown in Figure 6 result in a factor of safety of 1.45, assuming that there is no cohesion in the embankment or foundation and that the friction angle is constant at 35° . These assumptions of soil strength are considered conservative. Inclusion of earthquake forces equal to one-tenth the acceleration of gravity in the horizontal direction decreases the safety factor to 1.05. Earthquake forces are not generally considered in stability studies for earth dams in New England, however, we have included this possibility in our study because of the downstream occupancy. The low factor of safety for this extreme loading condition is considered satisfactory. In all stability calculations, the seepage forces caused by flow through the dam were included. To obtain realistic values of these forces, the free surface of flow was modified by field measurements as shown in the notes of Figure 1.
